# C30A Encounter Overview

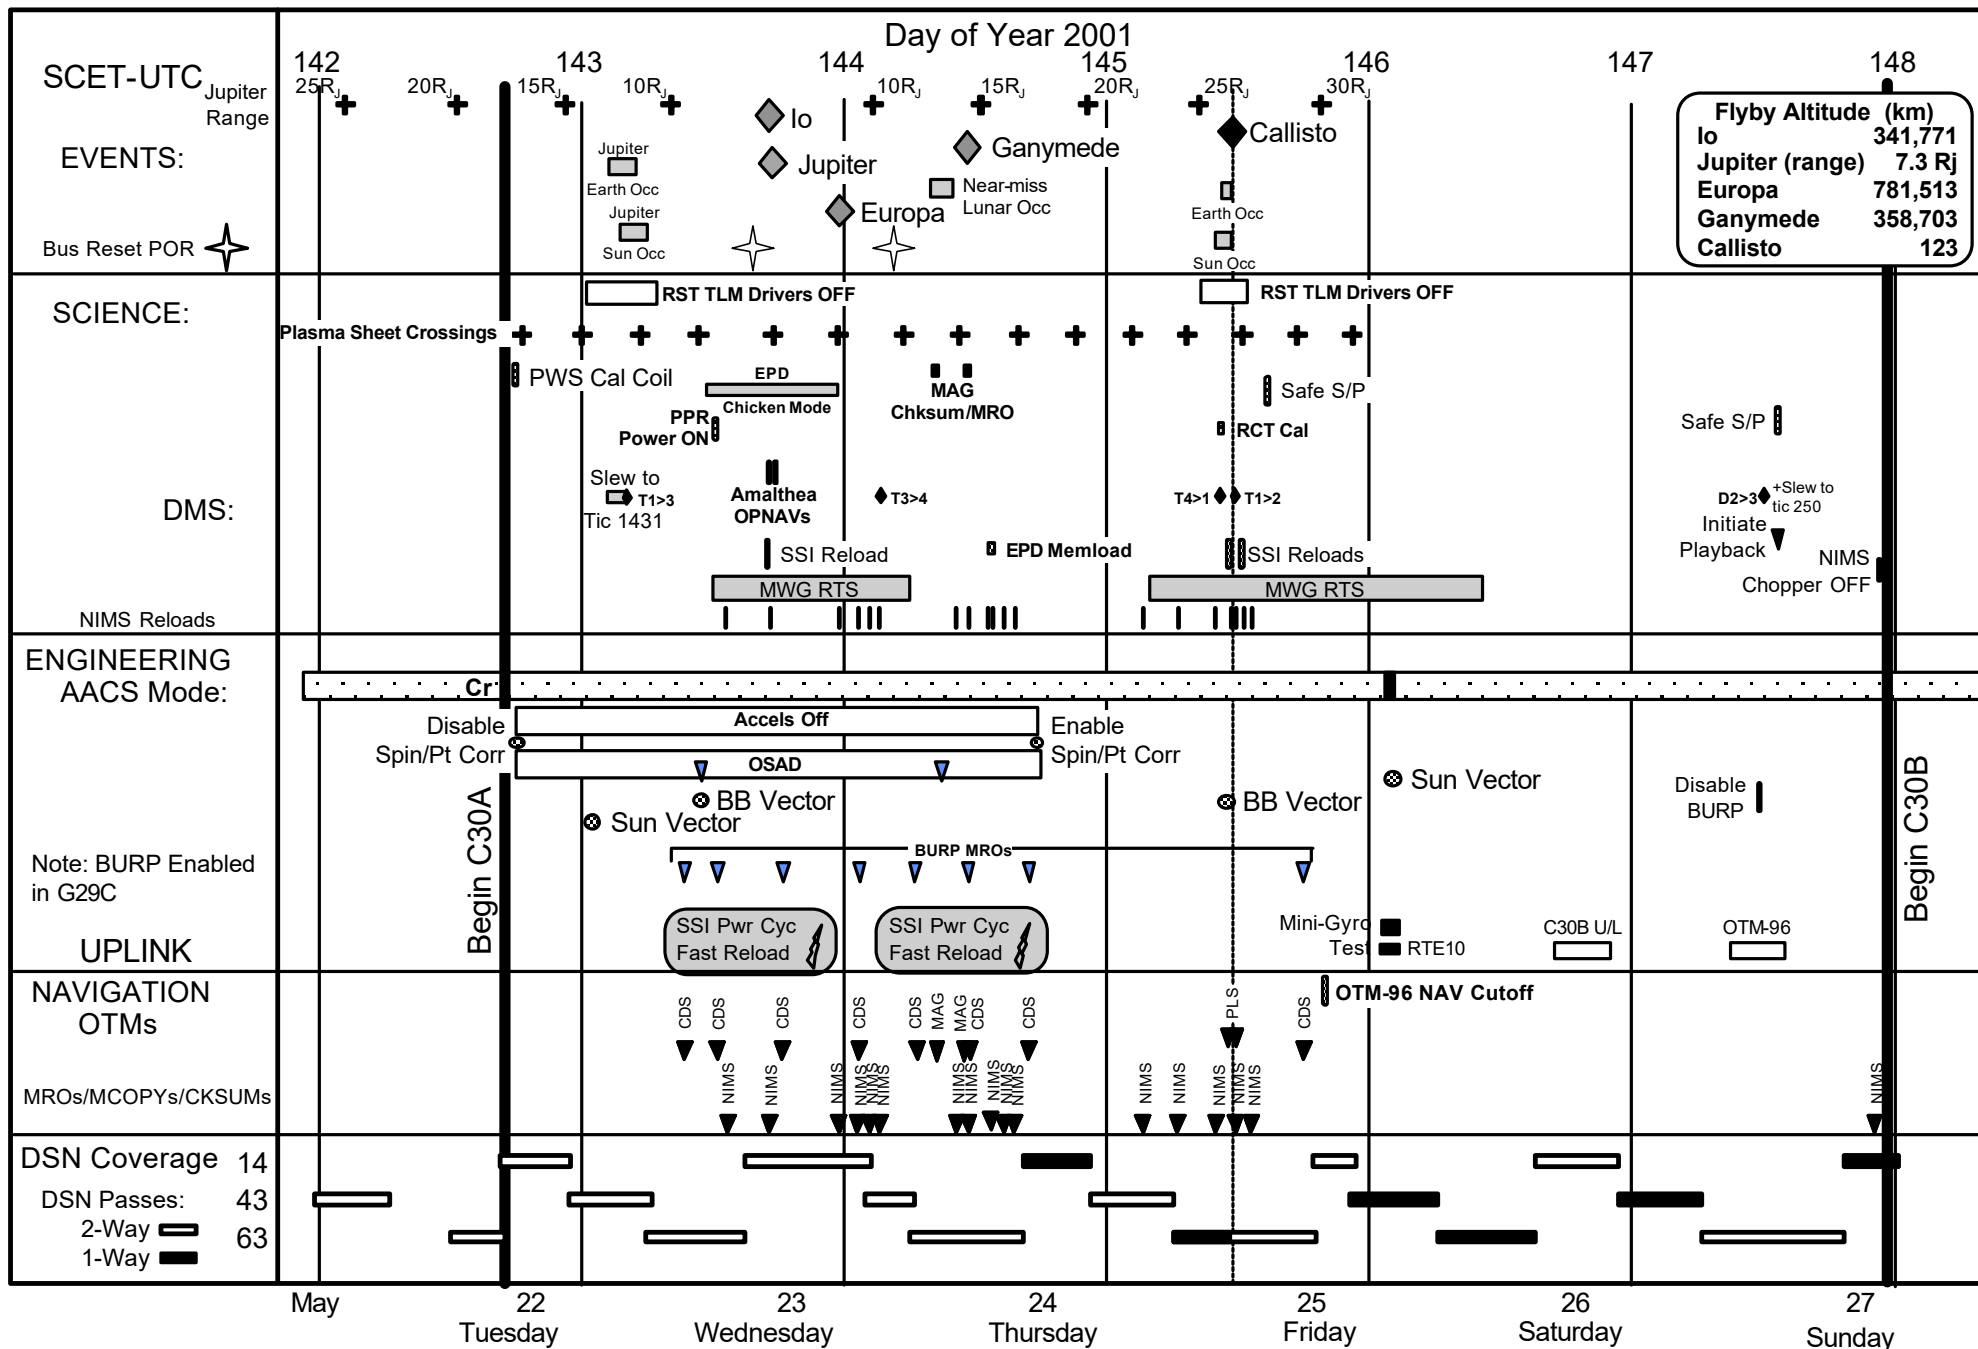
Note: Two Bus Reset PORs occurred during the encounter time period, both of which were properly handled by the on-board recovery routine.  
The times were: 01-143/15:49:08 SCET and 01-144/04:34:19 SCET.  
SSI Power cycle and fast reloads were sent at 01-143/21:30:00 TRM and 01-144/16:25:00 TRM.
